MTL TR 92-44

# LAU-7/A MISSILE LAUNCHER ATTACHMENT BOLT FAILURES

VICTOR K. CHAMPAGNE, MARC S. PEPI, and  
GARY WECHSLER

July 1992

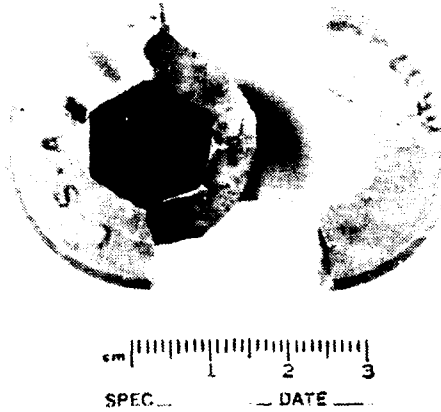
Both failed bolts were stamped on top of the head with the I.D. number 0507 which is the contract number identifying the manufacturer as Chosan, Inc. (see Figures 3a and 3b). Figures 4 and 5 show the two failed launcher attachment bolts identified by MTL as A and B, respectively, in the as-received condition. Both fractures occurred at the head to shank radius near the hexagonal recess. In the case of Bolt B, the primary crack front propagated through the thickness of the material (transversely) until the entire head of the bolt was completely severed, as shown in Figures 3b and 5. During the failure of Bolt A, the main crack front initially proceeded in the same manner but approximately halfway through the bolt, the crack then proceeded in a longitudinal direction until one half of the bolt head became detached from the part as depicted in Figures 3a and 4.

Figure 3a. Macrograph of launcher attachment Bolt A showing the fractured head with the identification number 0507. Reduced 5%.

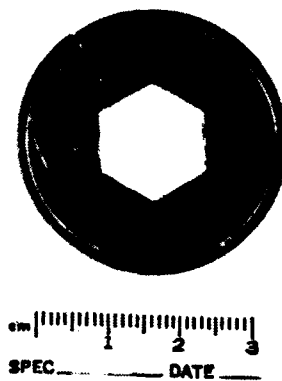
Figure 3b. Macrograph of launcher attachment Bolt B showing the fractured head with the identification number 0507. Reduced 5%.

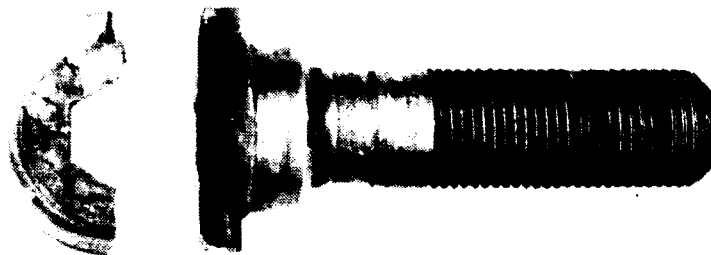
Figure 4. Macrograph showing launcher attachment Bolt A in the as-received condition. Mag. 1X.

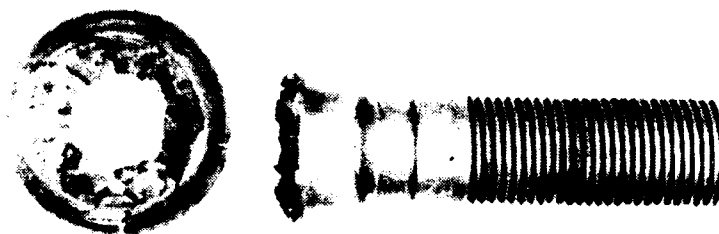
Figure 5. Macrograph showing launcher attachment Bolt B in the as-received condition. Mag. 1X.

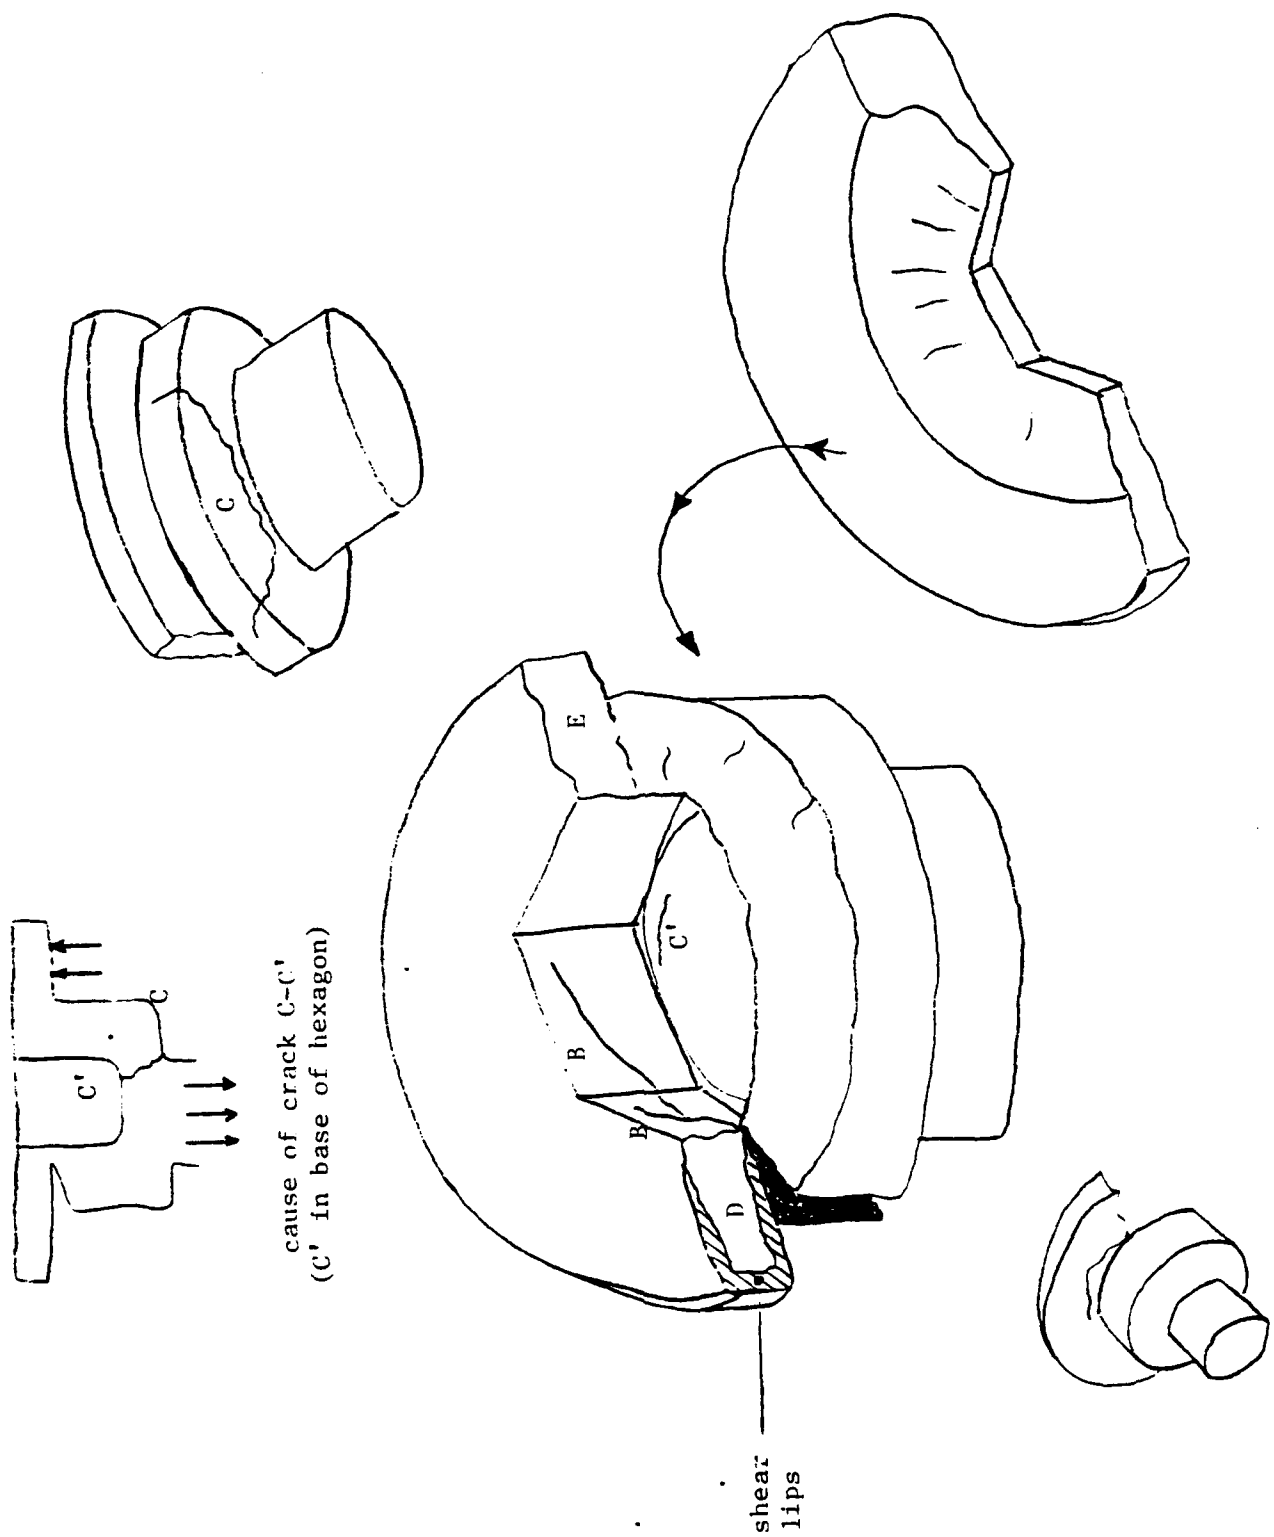
In Figure 7, Branch B broke out to the side and is the same crack as the vertical break A. A similar event caused the vertical break D and E in Figure 6, although in a different manner. In Figure 6, the crack C in the bottom of the hexagonal insert is the same as crack C at the next radius below the head. Its cause is explained in the top left hand schematic.

Figure 6. Bolt A failure schematic.

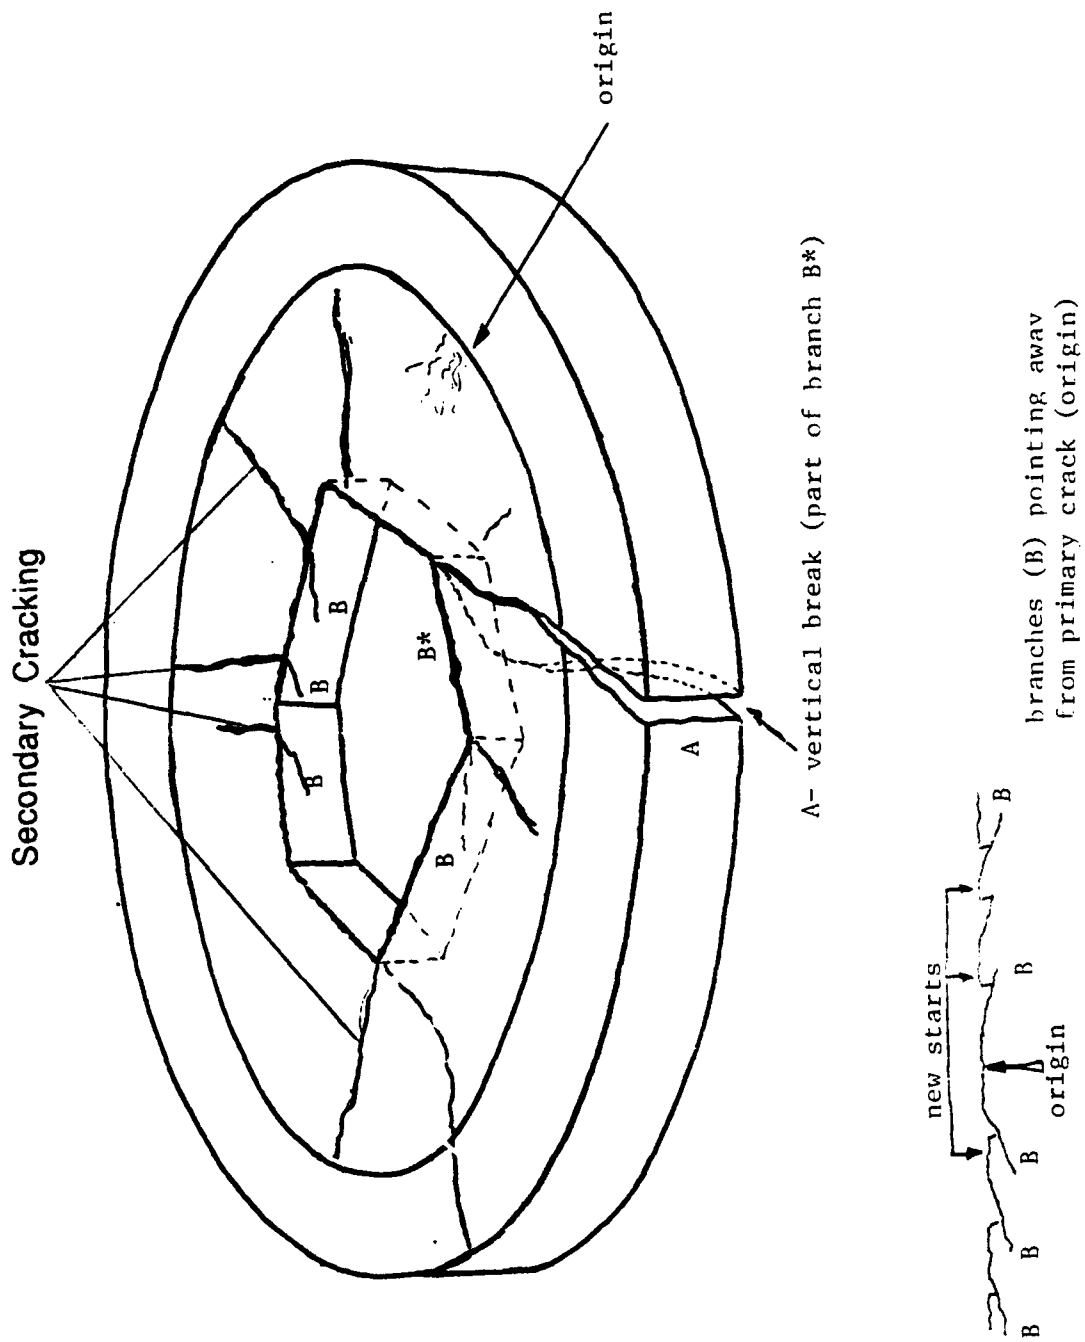
Figure 7. Bolt B failure schematic.

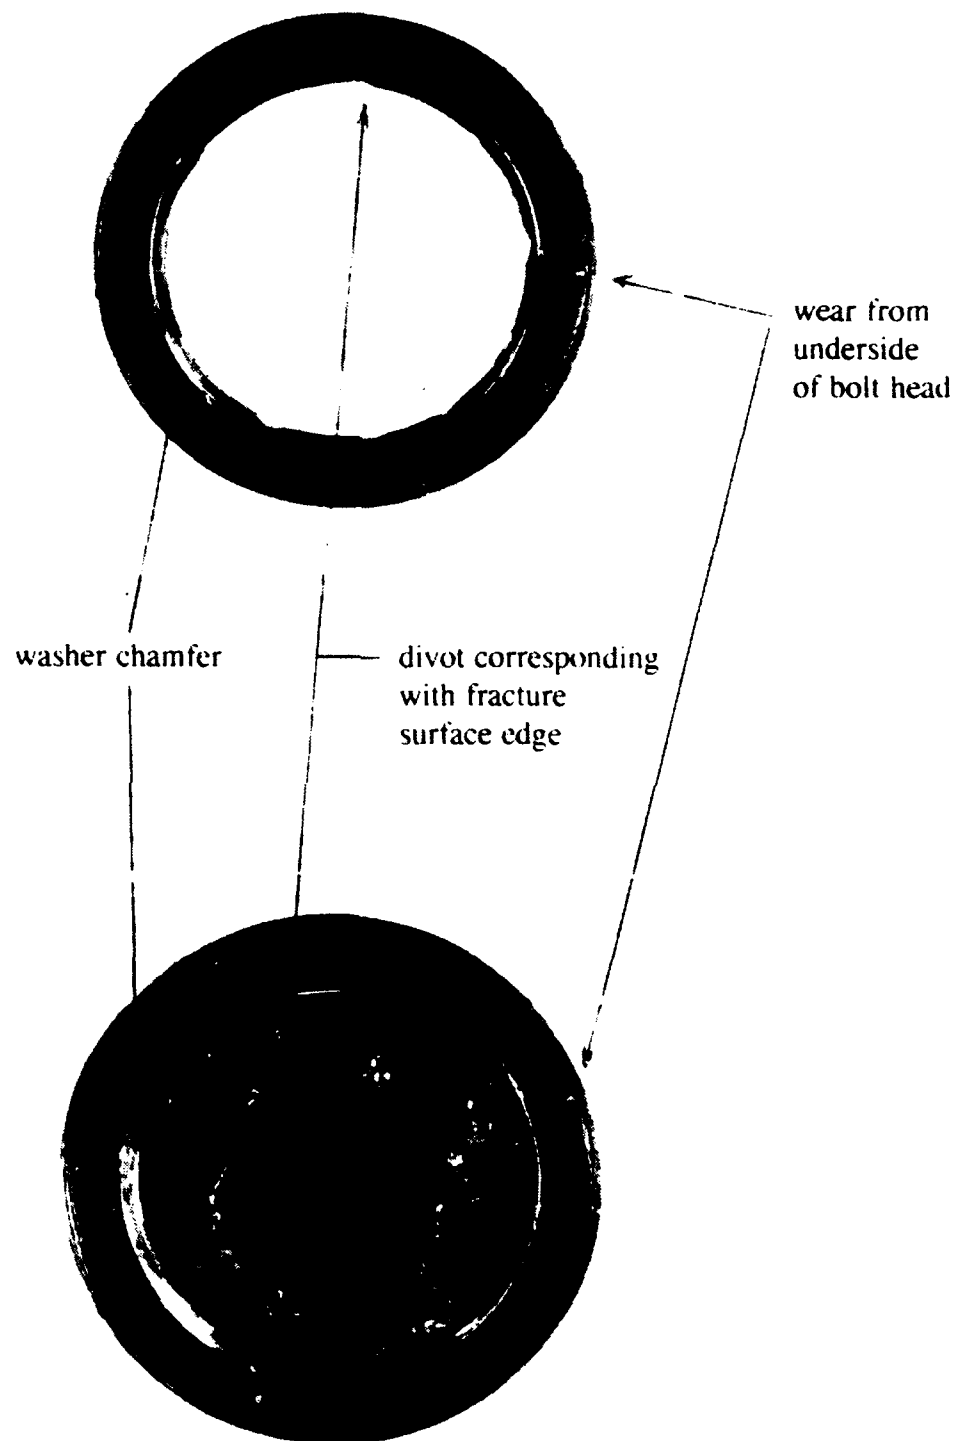
Examination of the washers used with each bolt revealed damage and wear which corresponded with the deformation contained on the head of the bolts. The washers were determined to have been installed properly on both bolts by matching the wear pattern and damage on the bolts with the washers. It was also noted that the washers could only be seated properly when placed right-side up on the bolt radius (see Figure 9), substantiating the fact that the washers were installed properly. No evidence of extensive corrosion pitting was observed on the outer bolt shank radius. Areas of corrosion were noted on the fracture surfaces and some wear was noted at the radius near the crack origin on both bolts, as Figure 10 shows.

Figure 9. Macrographs showing orientation in which bolt was seated on washer. Mag. 2X.

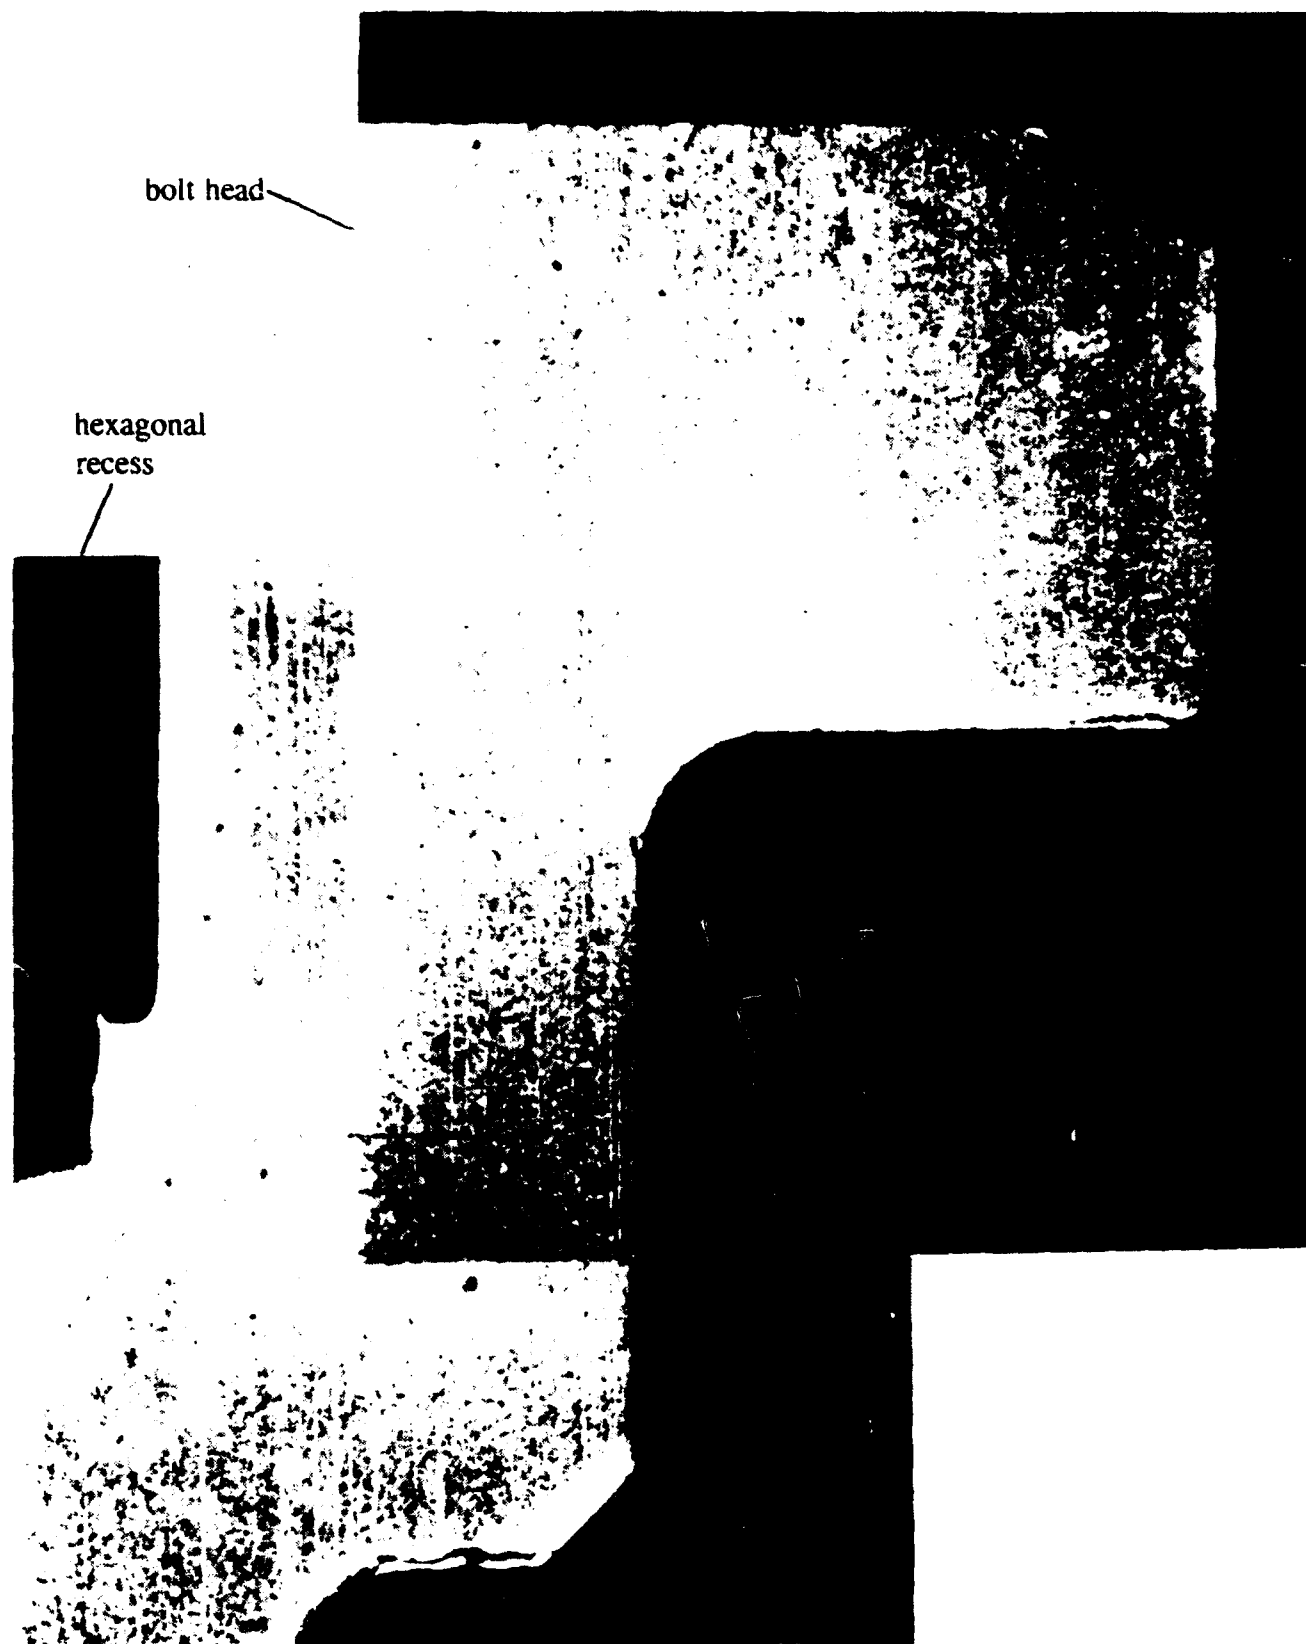
Figures 12 and 13 show the head region of a longitudinally sectioned 0507 and 0437 bolt, respectively. The samples were etched in a solution consisting of 50% hydrochloric acid and 50% water for 15 minutes. The nature of the flow lines on each sample indicated the bolts were machined and not forged. It was determined the bolts did not conform to 3.4.2.1.1 of AMS 7455E:

Figure 12. Macrograph of the macrostructure of a representative 0507 bolt head.  
Flow lines were indicative of a machined bolt head. Mag. 12.5X.

The current supply of LAU-7/A launcher attachment bolts manufactured by Chosan, Inc. have been machined and not forged as required; therefore, if new components fabricated to the requirements of NAVAIRSYSCOM Engineering Drawing 58A164C57 Rev. T cannot be procured in a timely fashion, then launcher attachment bolts currently in service that have been determined to be carburized should be replaced with those that are not. MTL has examined samples of bolts from eight heat treat lots representing contract 0507 (provided by the PMTC) and through metallographic examination and hardness testing has concluded that heat treat lot 12/90 does not display evidence of carburization. Heat treat lot 4/91 was found to have a minimal level of carburization optically, but microhardness testing results were to the high side of the acceptable range and macrohardness testing on the exterior surface was similar in value to other carburized heat treat lots (see Tables 5 and 6); therefore, the condition of heat treat lot 4/91 was classified as questionable.

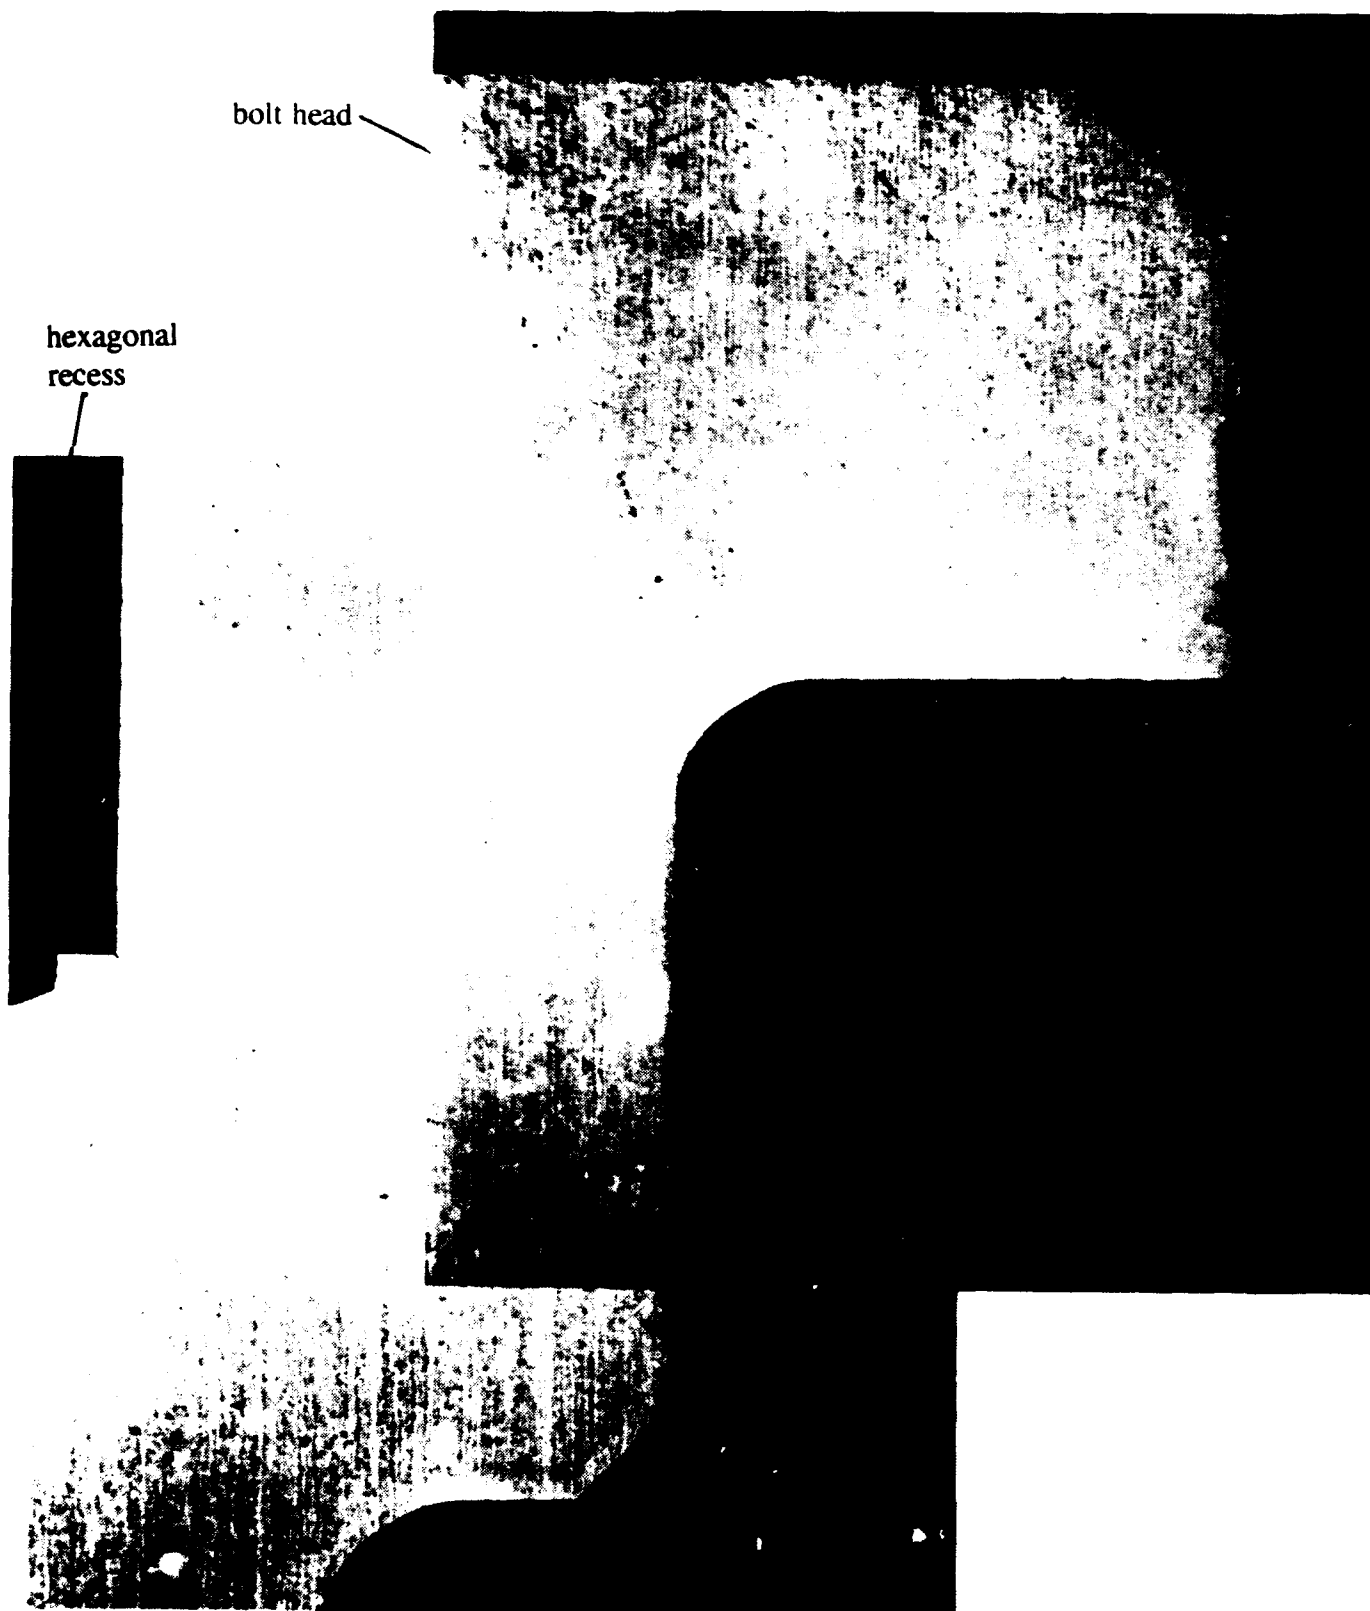
Figure 13. Macrograph of the macrostructure of a representative 0437 bolt head.  
Flow lines were indicative of a machined bolt head. Mag. 12.5X.

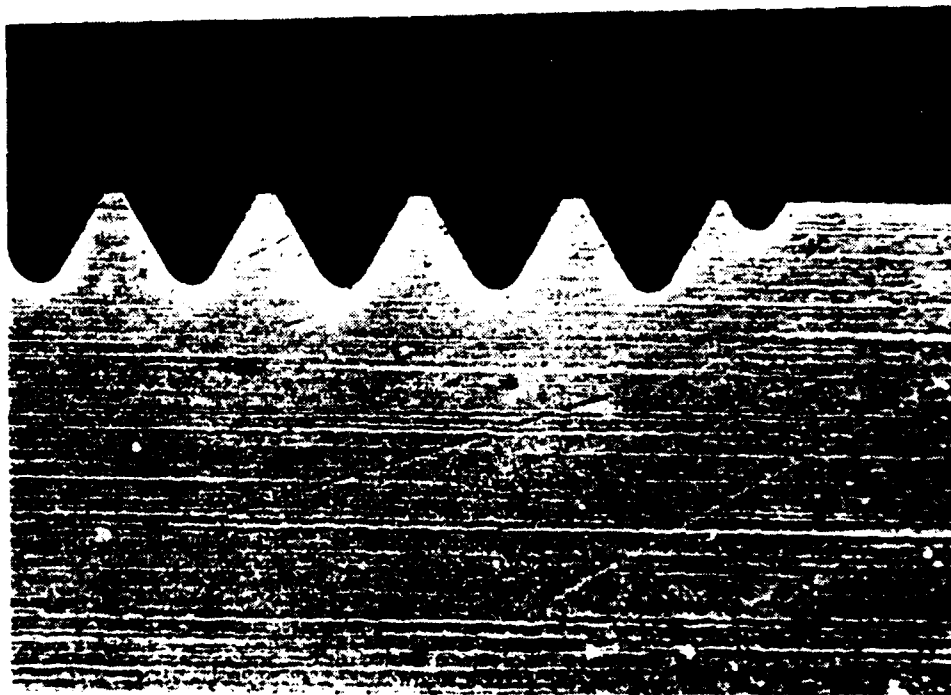
Figures 15 and 16 show the threads of longitudinally sectioned typical 0507 and 0437 bolts, respectively. The samples were etched in a solution consisting of 50% hydrochloric acid and 50% water for 15 minutes. Note the direction of the flow lines within the thread. The flow lines did not follow the contour of the thread, indicative of a cutting or grinding thread forming procedure. It was determined that the bolts did not conform to 3.4.2.1.2 of AMS 7455E:

Figure 15. Macrograph of the macrostructure of a representative 0507 bolt thread region. Flow lines were indicative of machined threads. Mag. 12.5X.

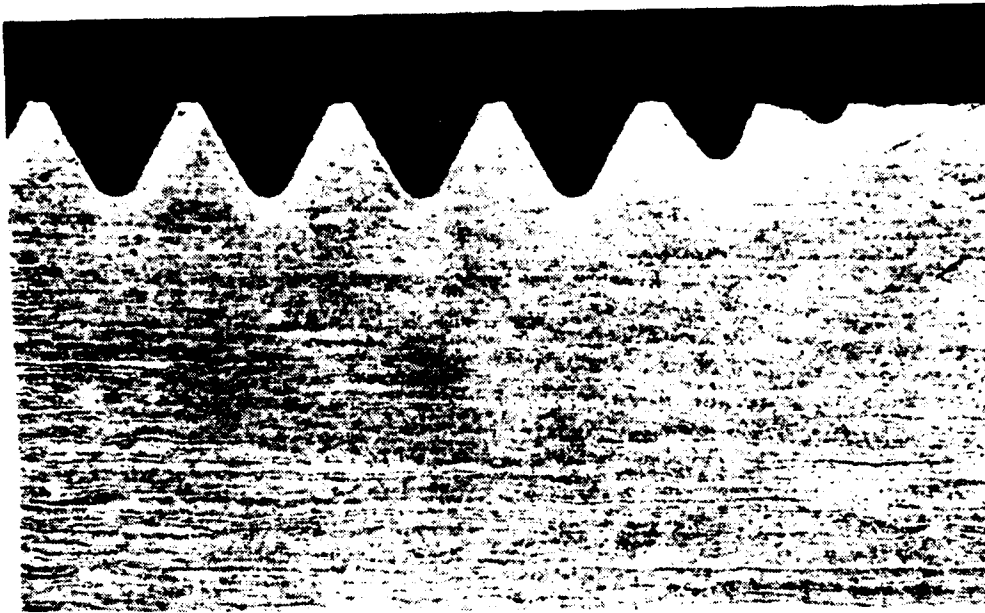
Figure 16. Macrograph of the macrostructure of a representative 0437 bolt thread region. Flow lines were indicative of machined threads. Mag. 12.5X.
